RL-TR-95-19 Final Technical Report February 1995

# CORRELATION OF WAFER LEVEL QA TESTS WITH FUNCTIONAL DEVICE YIELD AND ACCELERATED LIFE TEST RESULTS

University of Southern California

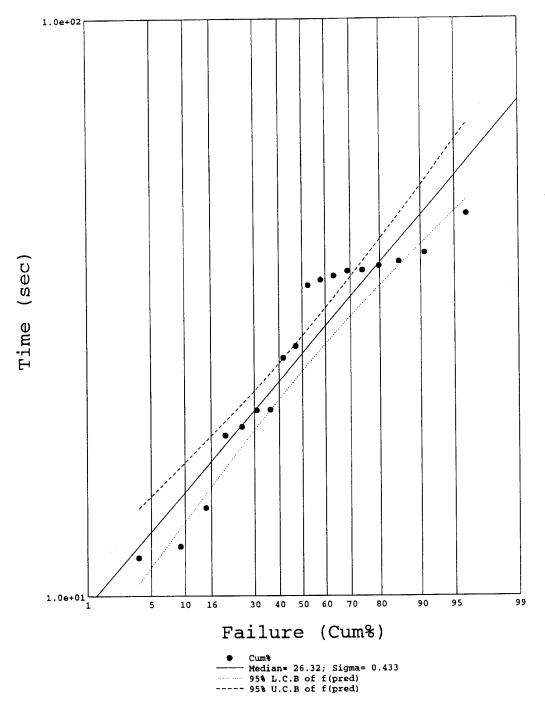
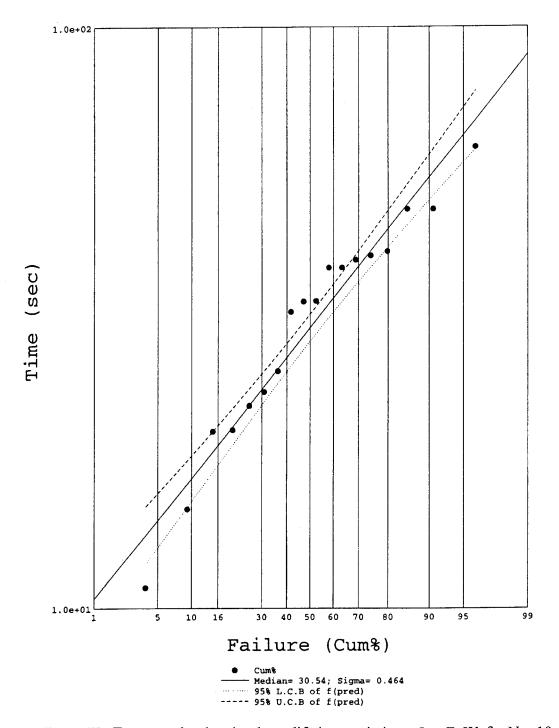
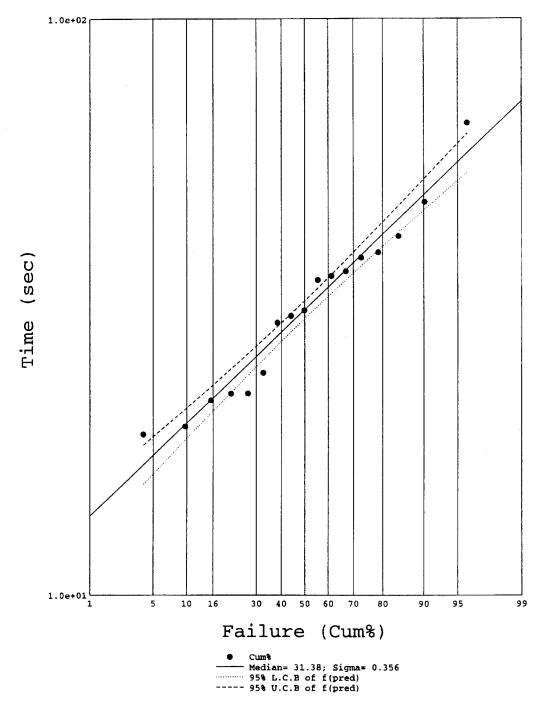
The most interesting electromigration test results were from Vendor B. As indicated above we were unable to conduct complete package level tests because metal connections to the on-chip heater show rapid electromigration failures. In addition the SWEAT test results were very erratic. Referring to Figures 4a - 4f it can be seen that there are wild variations in the  $t_{50}$  results from SWEAT testing. Sigmas were reasonably small, but the median time to fail data indicates a substantial wafer to wafer variation in metal quality. The data given for this run (Lot F) is typical of the other wafer lots from Vendor B.

Figure 4a: SWEAT test results showing large lifetime variations- Lot F, Wafer No. 9. Approximately normal for the calibration used.

Figure 4b: SWEAT test results showing large lifetime variations- Lot F, Wafer No. 10. Approximately normal for the calibration used.

Figure 4c: SWEAT test results showing large lifetime variations- Lot F, Wafer No. 11. Approximately normal for the calibration used.

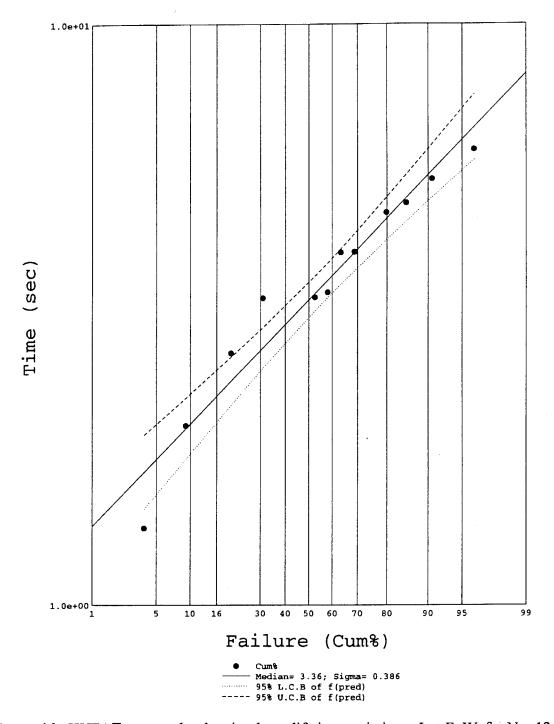
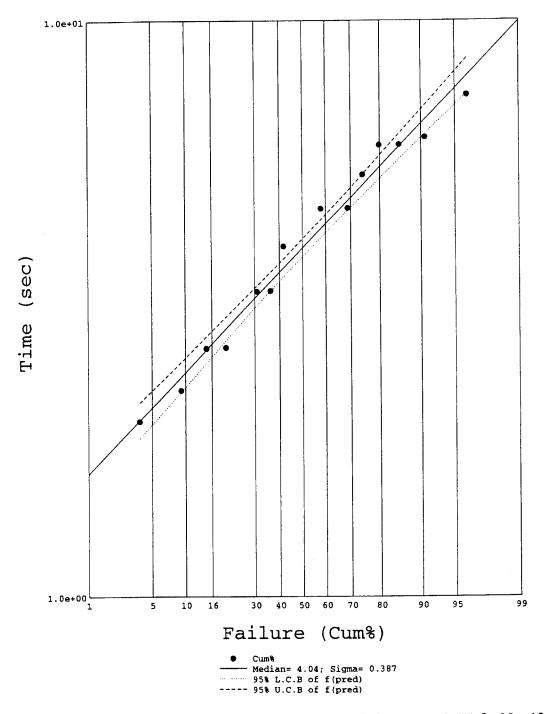
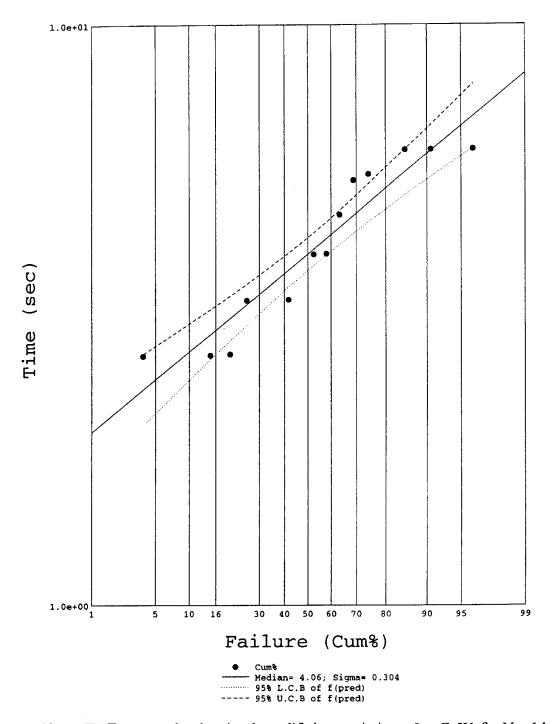
We concluded that, based upon these electromigration test results that the Vendor B wafer lots would have significant signs of electromigration damage, possibly including some open metal failures, in the SEC devices operated in the test oven at 175°C.

Figure 4d: SWEAT test results showing large lifetime variations- Lot F, Wafer No. 12. Extremely unusual variation from normal.

Figure 4e: SWEAT test results showing large lifetime variations- Lot F, Wafer No. 13. Extremely unusual variation from normal.

Figure 4f: SWEAT test results showing large lifetime variations- Lot F, Wafer No. 14. Extremely unusual variation from normal.

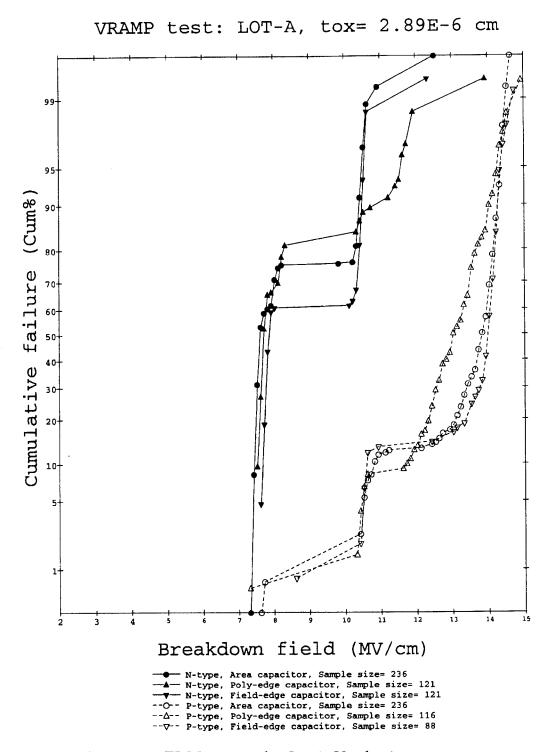
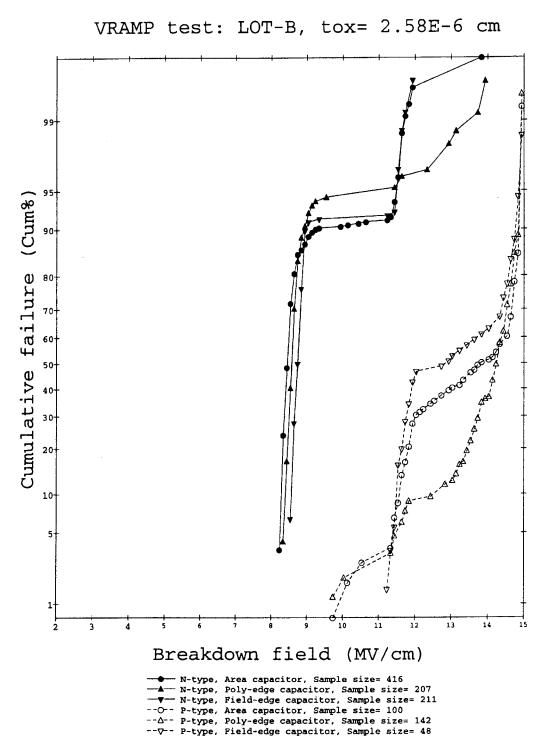
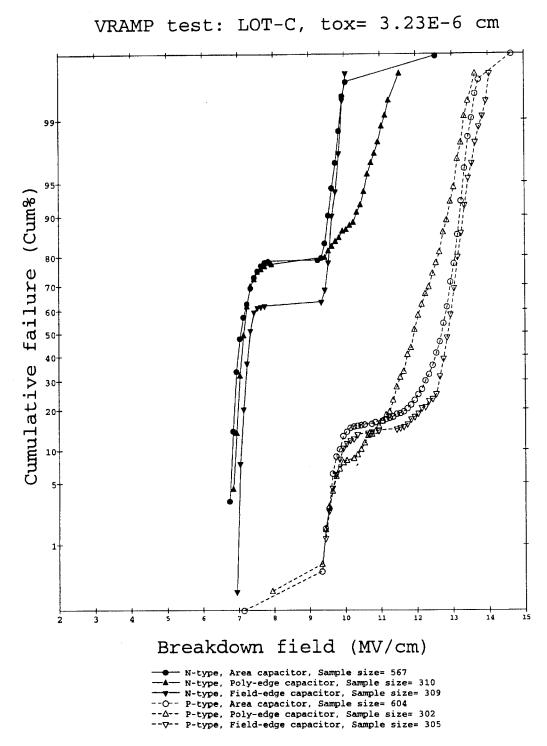
All of the Vendor A lots (Lot A, Lot B, Lot C in Figures 5a - 5c respectively) show no recognizable defect tail in the Voltage Ramp breakdown and have a median (intrinsic) failure field on the order of 8 to 10 MV/cm. This is further evidence that the number of oxide defects is rather small. The SEC devices from these lots will likely have high yield and are not likely to show significant life test failures attributed to TDDB. There is not sufficient area in these test capacitors to measure the defect tail on these wafer lots.

Figure 5a: Voltage Ramp TDDB test results- Lot A, Vendor A.

Figure 5b: Voltage Ramp TDDB test results- Lot B, Vendor A.

Figure 5c: Voltage Ramp TDDB test results- Lot C, Vendor A.

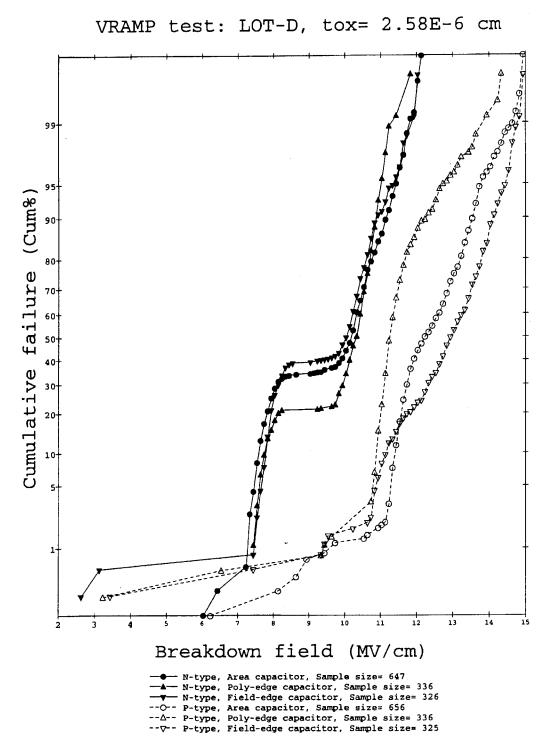
The Vendor C wafer lot (Lot D Figure 5d) shows a median intrinsic breakdown field on the order of 8 to 10 MV/cm, similar to what was seen in the Vendor A lots. However, there is definite evidence of a defect tail extending down to a little over 3 MV/cm. The intrinsic population is not as tightly grouped as the Vendor A lots. This would indicate that there will be a decreased SEC yield relative to the Vendor A lots. It also indicates that there may be a significant number of life test failures, because of the higher average defect density indicated by the presence of the defect tail.

Figure 5d: Voltage Ramp TDDB test results- Lot D, Vendor C.

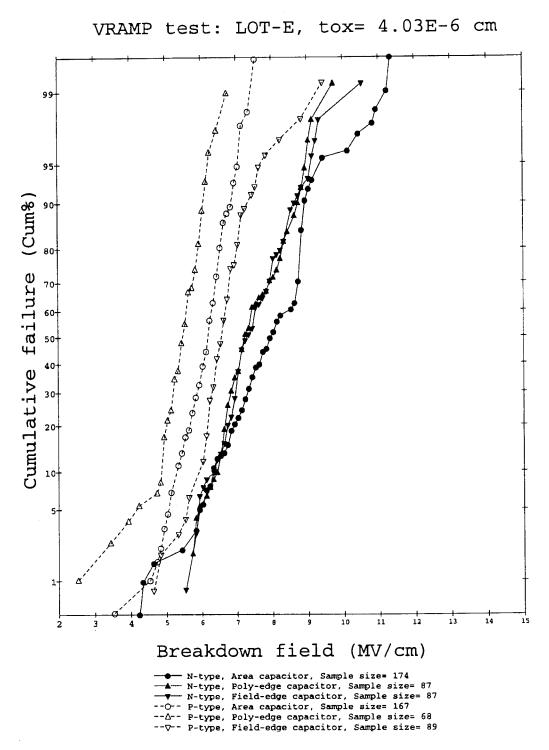
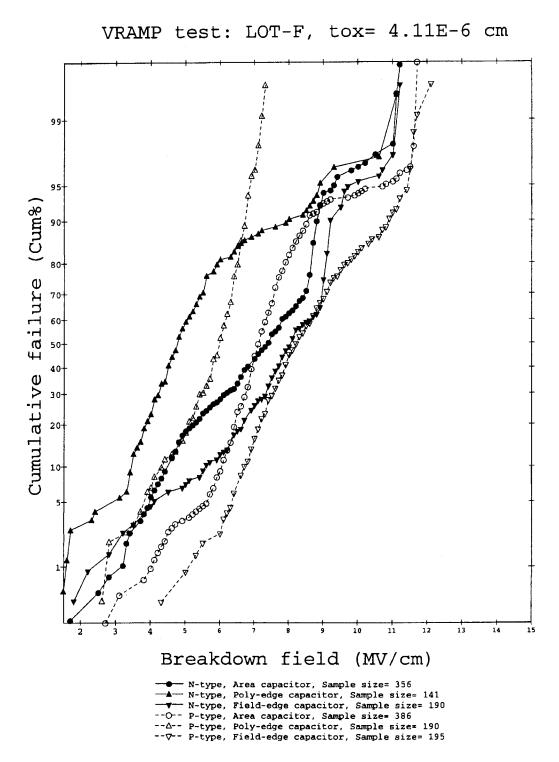
Vendor B wafer lots (Lot E and Lot F, in Figures 5e and 5f)are dramatically different from the above wafer lots. There is essentially no tightly distributed tightly grouped intrinsic component to the failure distribution. The entire failure distribution is widely spread from the operating field up to about 10MV/cm, suggesting that the failures are strongly dominated by defect related failures. These results indicate the likelihood that there will be a very high SEC yield loss due to oxide defects.

Figure 5e: Voltage Ramp TDDB test results- Lot E, Vendor B.

Figure 5f: Voltage Ramp TDDB test results- Lot F, Vendor B.

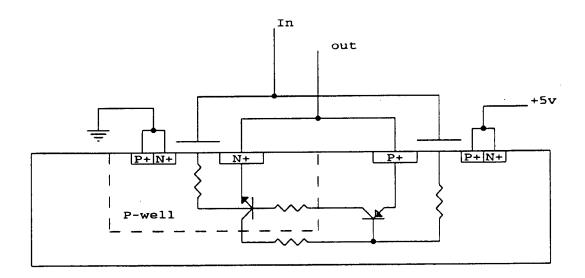
Gate oxide failure caused latch-up is a logical explanation of this high incidence of bond wire failures. If one thinks about what happens when a gate oxide failure occurs, in an N-channel transistor of an inverter in a p-well process, it is possible to describe the gate to substrate connection as the trigger input to the latch-up SCR (Silicon Controlled Rectifier). Figure 7 contains a diagram of a CMOS inverter substrate cross section, with an overlay of the latch-up bipolar transistors showing parasitic resistors from the MOS transistor channel region to the bipolar transistor base connections. Referring to Figure 7, when the N-channel transistor gate oxide breaks down and connects the gate to the channel, and when the gate potential is a logical "1" (5.0 Volts), the current is supplied to the base of the vertical NPN transistor of the latch-up pair in the inverter. As a result, latch-up will occur as soon as the input is a logical "1". A similar

scenario applies to a gate oxide failure in the P-channel transistor, with latch-up trigger occurring with the input at a logical "0".

Figure 7: Latch-up Triggering by gate oxide failure. Parasitic BJT's are shown in a CMOS inverter Cross section diagram. The transistor diagram inside this figure illustrates the equivalent latch-up circuit. An oxide breakdown will provide a resistive path to the base of either the NPN or PNP transistor which will serve as the trigger for latch-up.
